Howan House, Orkney

Renovation and repairs to a 17th century house

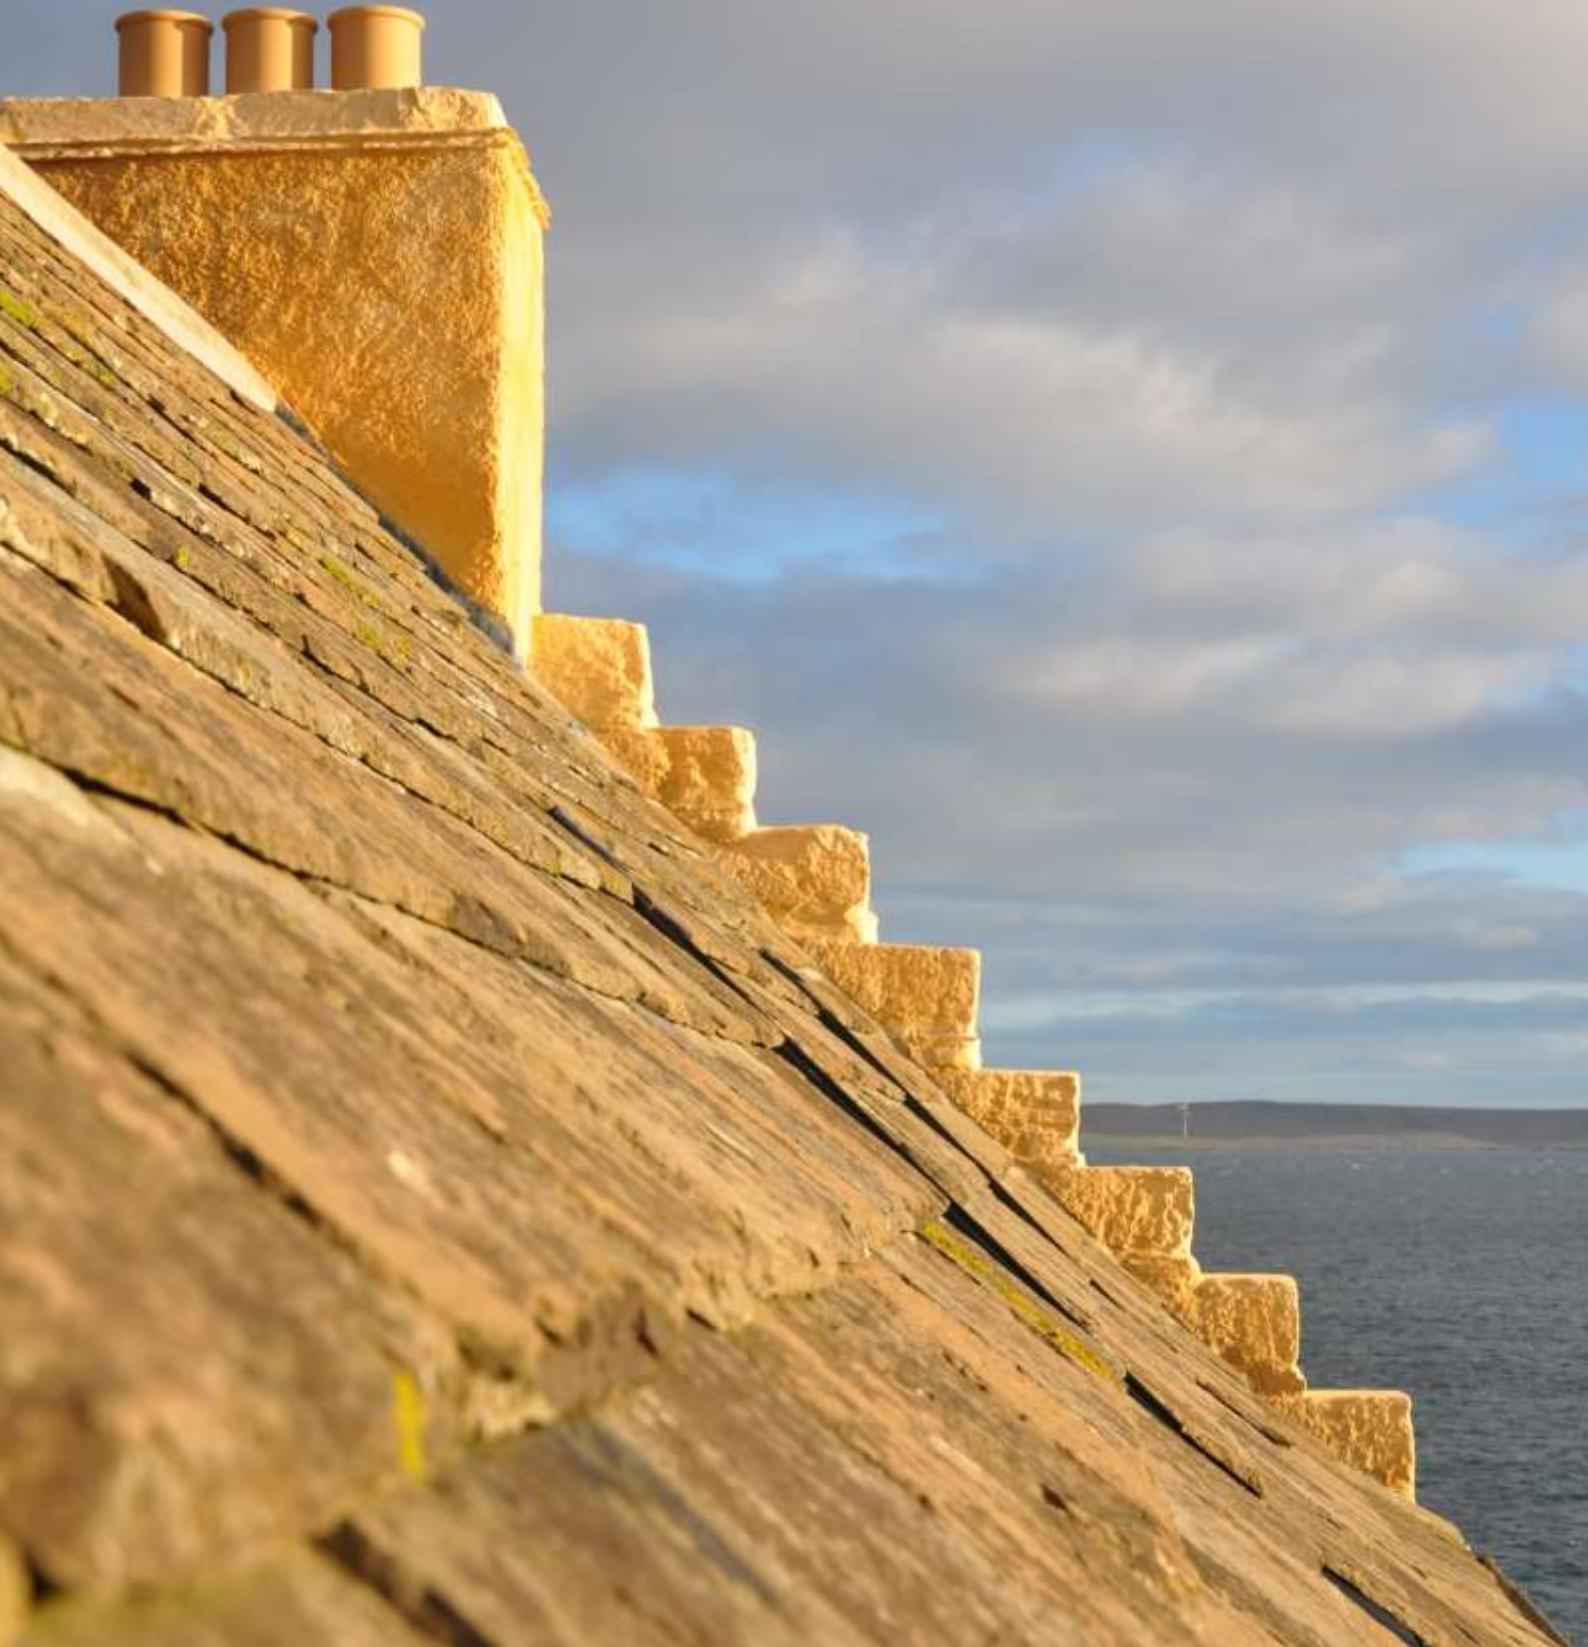
The views expressed in commissioned case studies are those of the authors and do not necessarily represent those of Historic Environment Scotland.

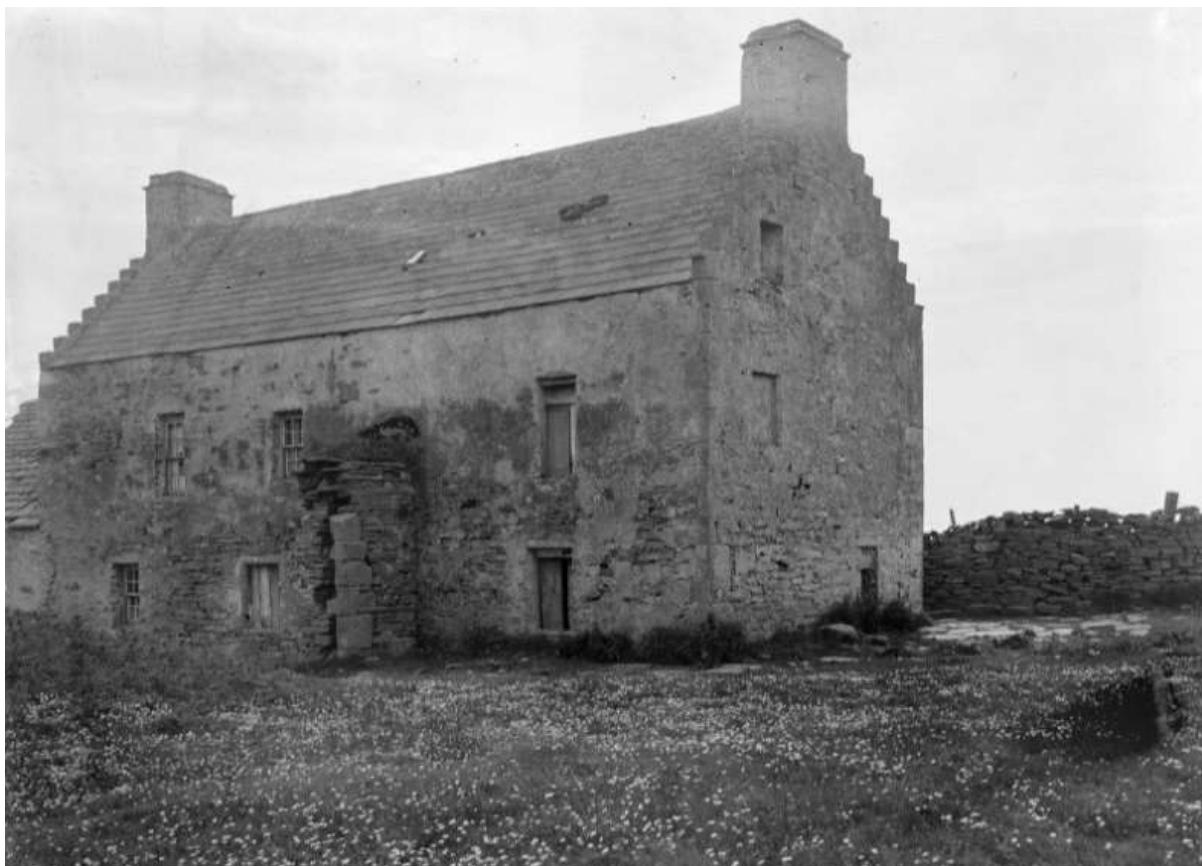
Figure 1: Image from the early 20th century showing the north elevation with roof still intact
(© Historic Environment Scotland)

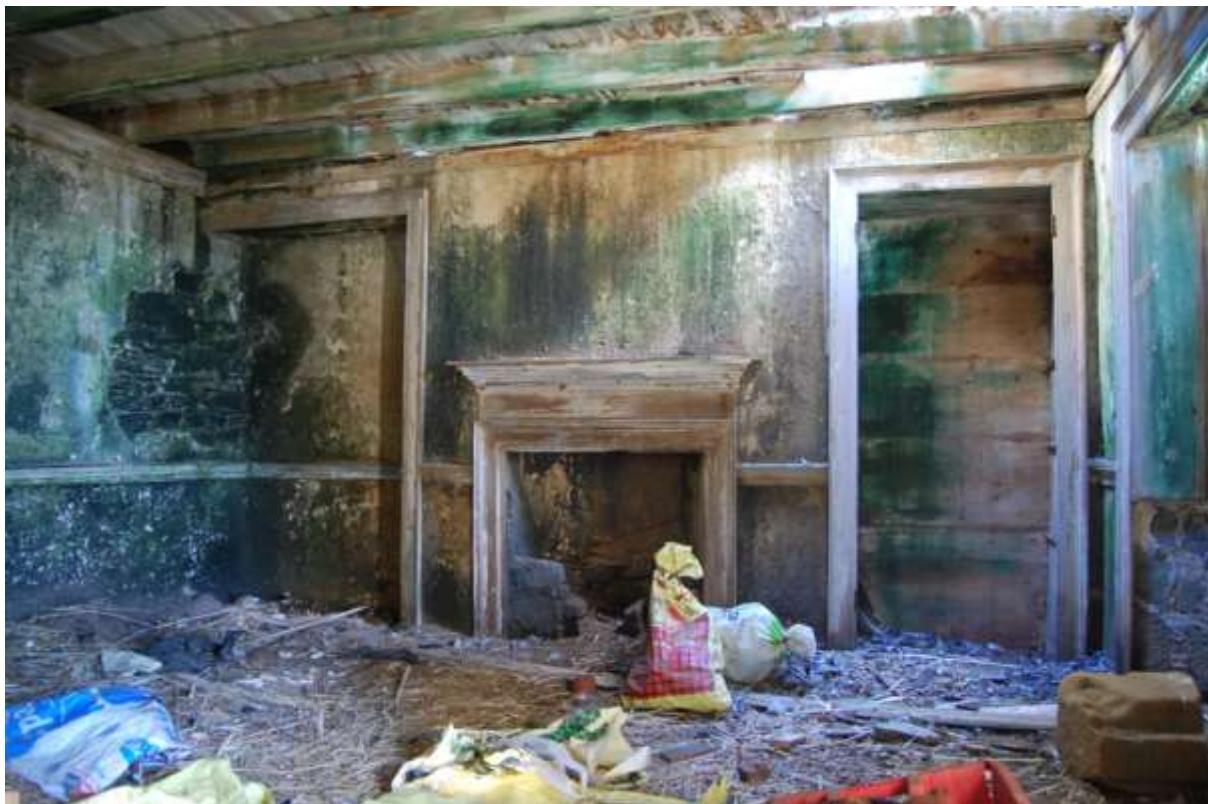
Figure 2: Interior of the dining room before works with joinery details still intact

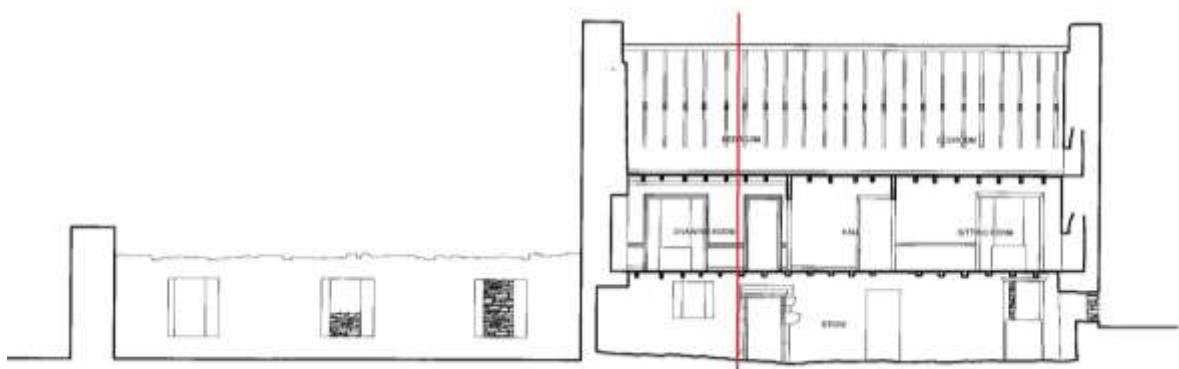
Figure 8: East-west section showing the change in joist form

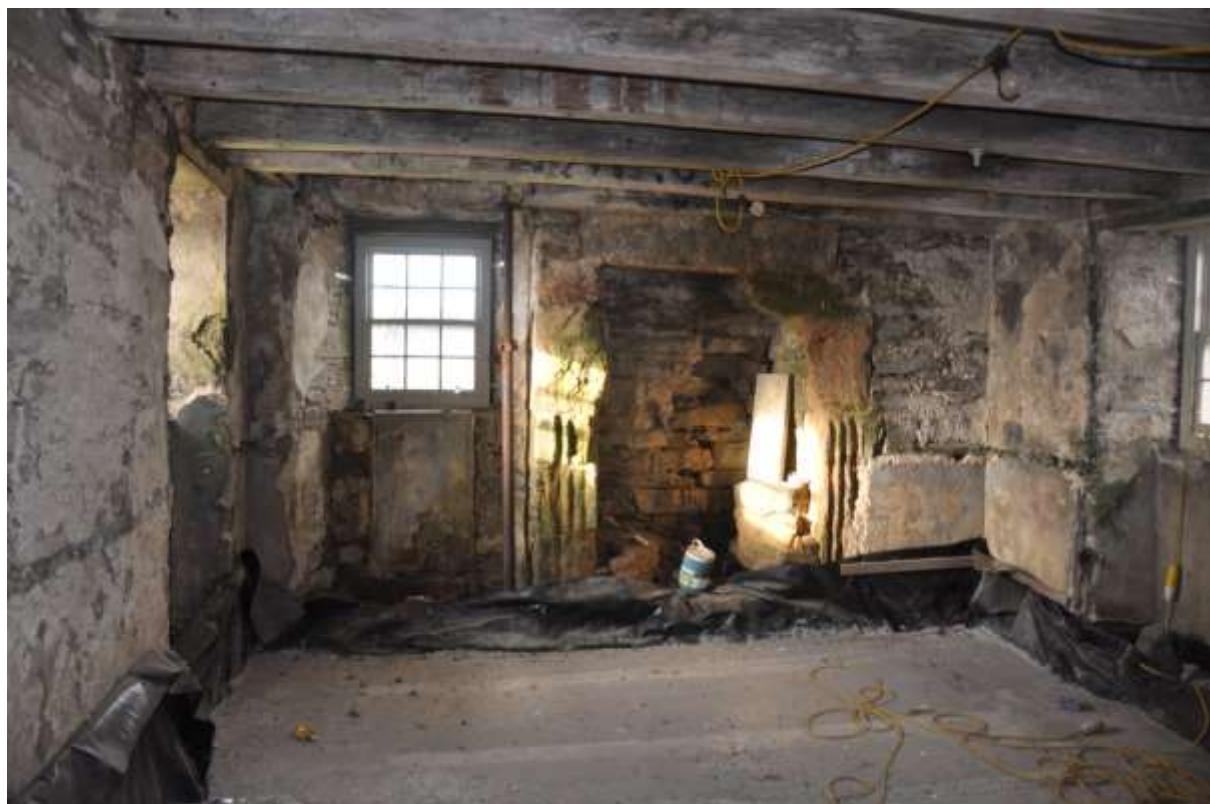
Figure 9: Remains of fireplace in the west wall on the ground floor

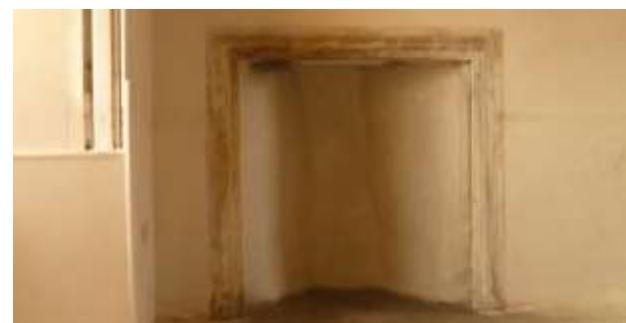
Figure 13: First floor, west gable hearth during repair, with a simply detailed moulded wooden surround

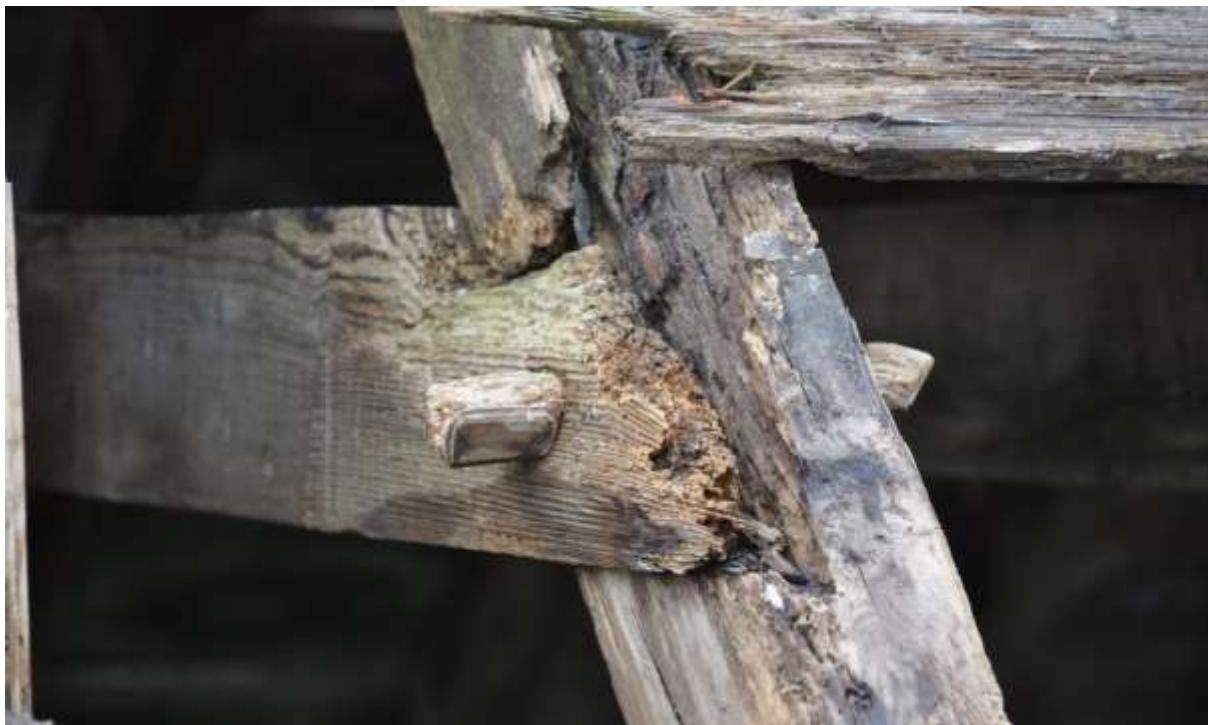
Figure 14: Timber peg and chamfered collar detail

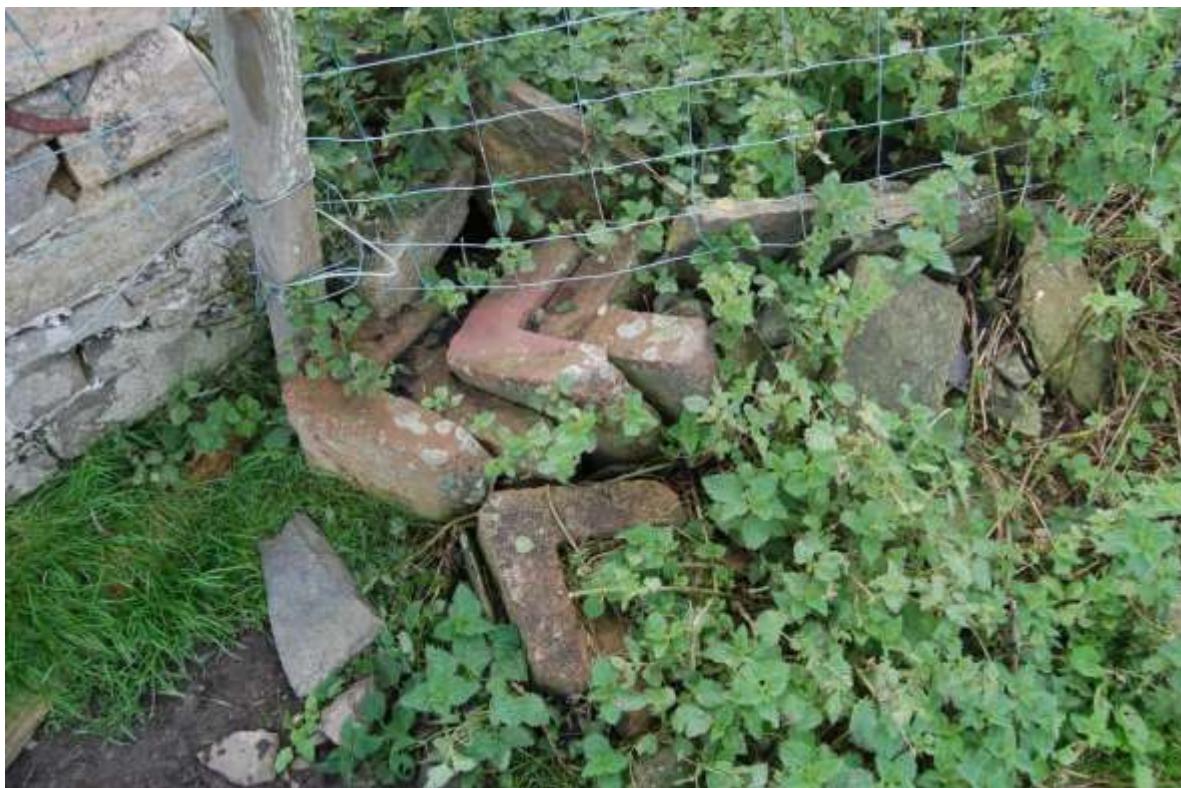
Figure 16: Short but substantial ridge stones, formed of sandstone of a pinkish hue, found on site

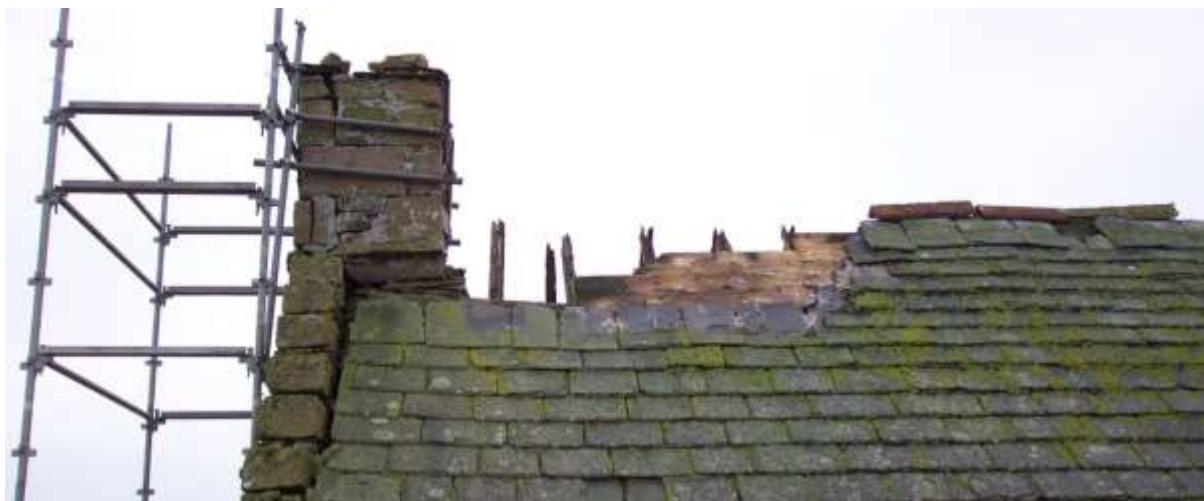
Figure 17: North gable chimney stack showing the gable separation from the roof structure

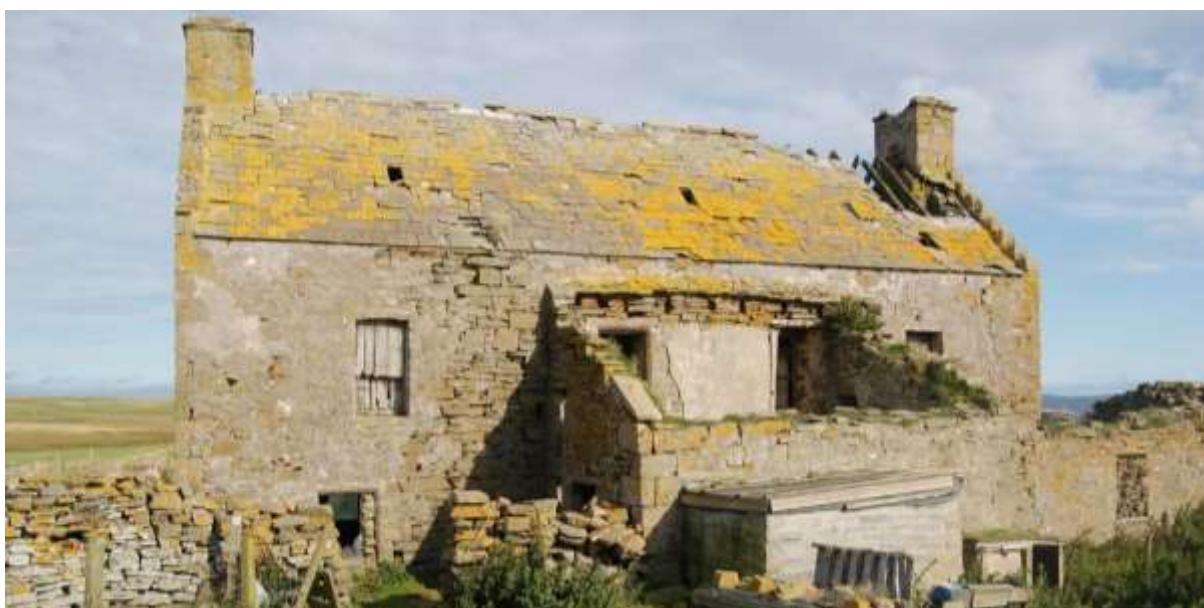
Figure 18: South elevation with vertical crack to the east. The pockets in the masonry of the wall in the entrance wing where the rafters would have been bedded are visible

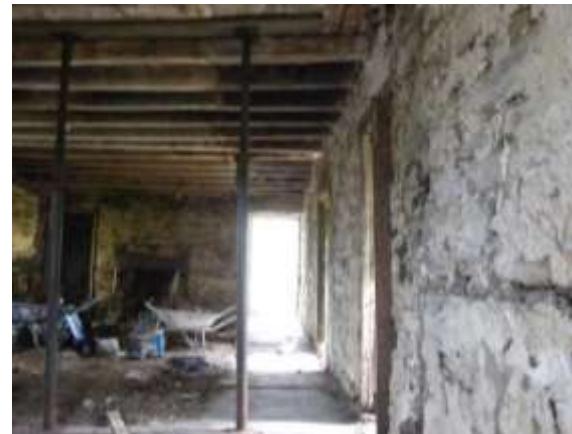
Figure 19: Existing ground floor condition with temporary props supporting the floors and the masonry partition above

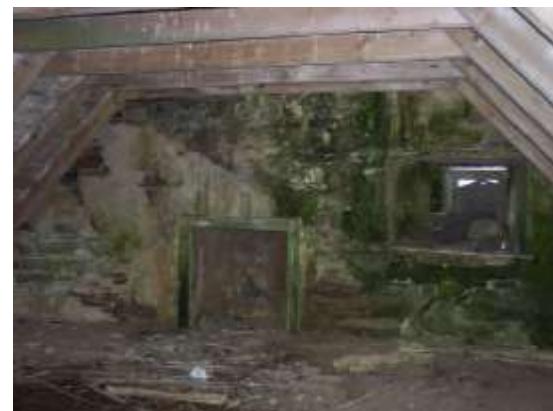
Figure 20: Existing attic condition

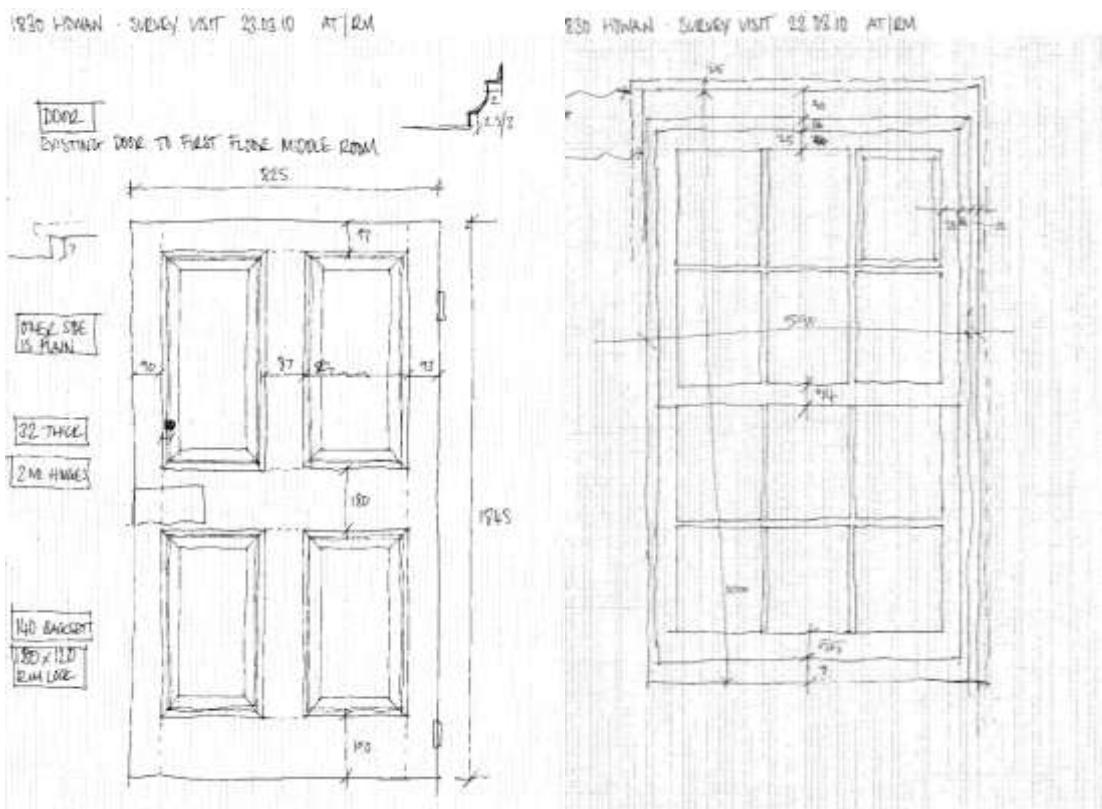
Figure 21: Examples of initial survey drawings, intended to record architectural details prior to works

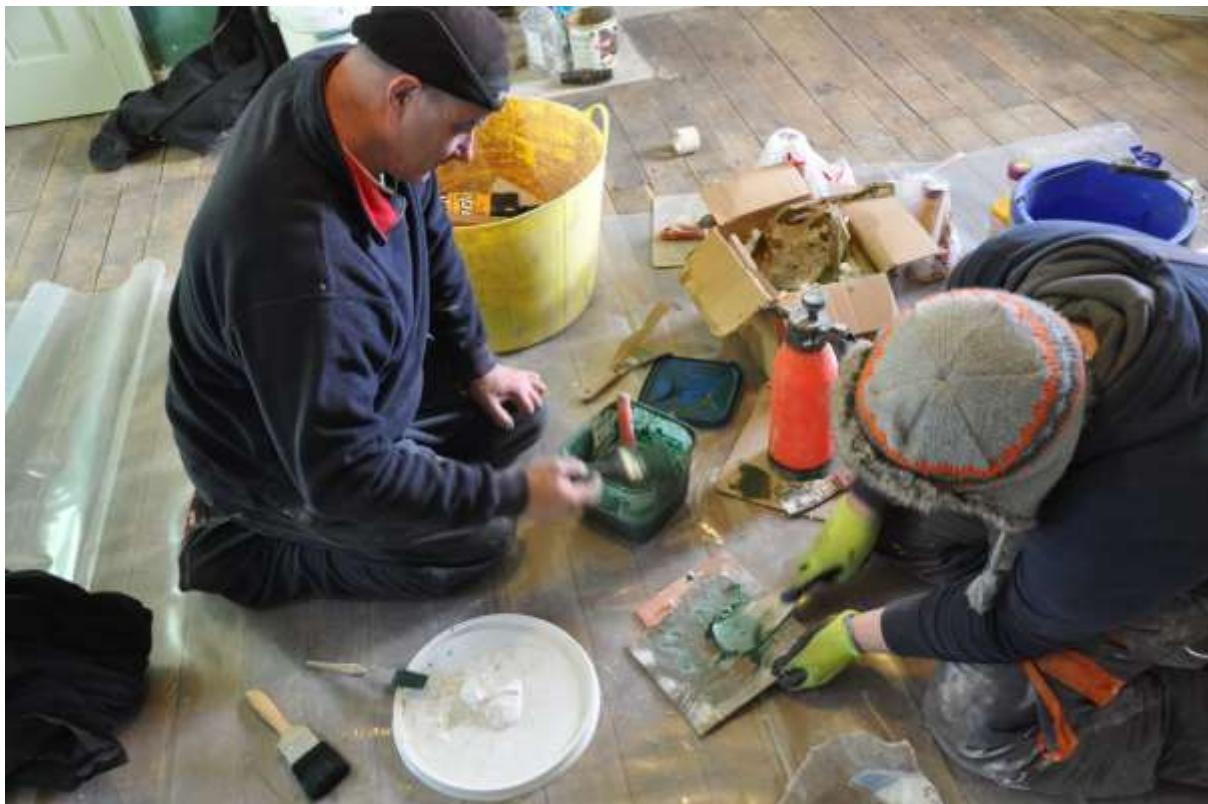
Figure 25: Local plasterers learning how to mix the lime plasters and paint from the lime consultant
Due to the remote nature of the site, the project architects only visited the site three times. During the summer the small car ferry is often fully booked with tourist traffic; this meant that any plant required had to be booked well in advance and any material deliveries had to be timed precisely. A van would then pick up the materials at the quay and transport them to the house. The local contractors were used to working this way, and were very resourceful with materials and time. For this reason, any materials on site that could be reused were salvaged to save on transport, cost and time.

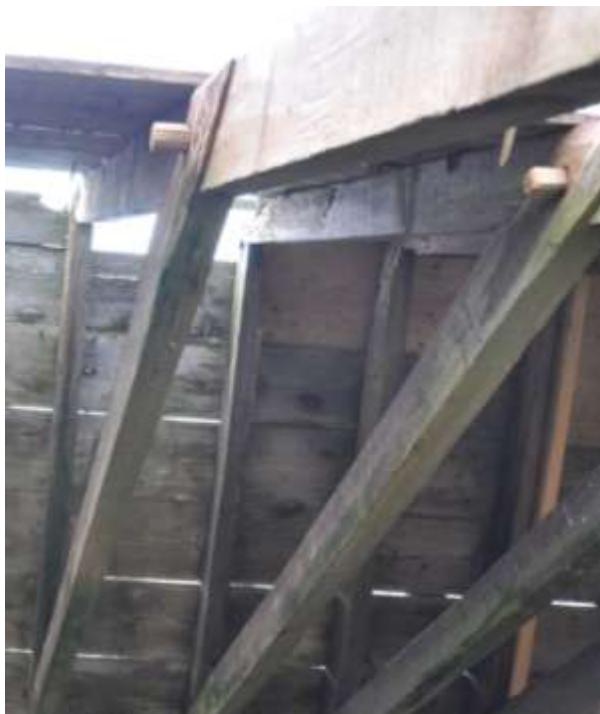
Figure 26: Repaired timber rafters, with splicing on the furthest right rafter

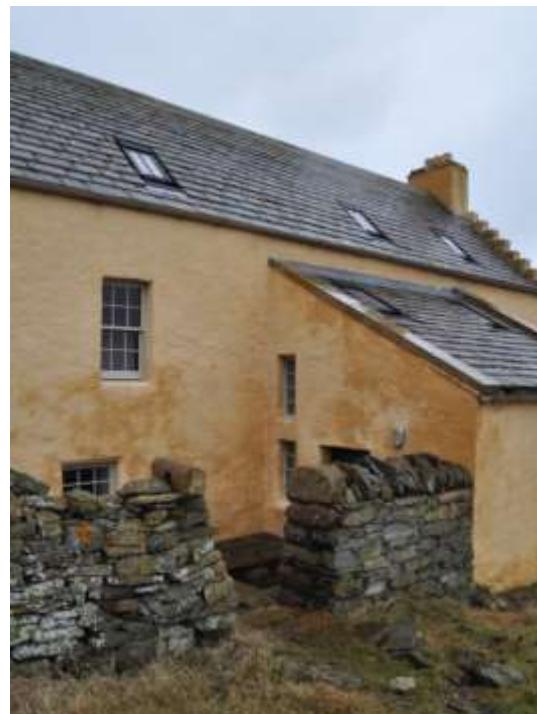
Figure 27: Repaired timber roof with original and reclaimed slates

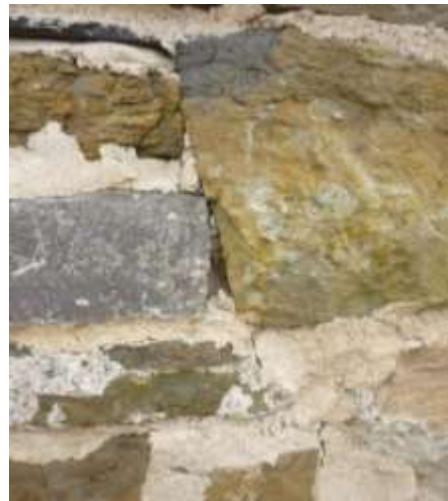
Figure 28: Section of the external wall showing existing lime mortar at the top and new lime mortar

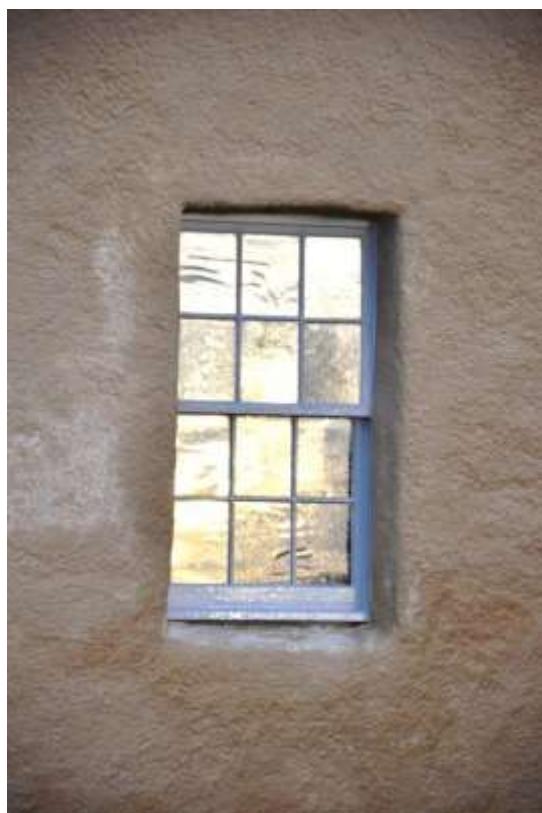
Figure 30: New single glazed sash and case windows with cylinder glass

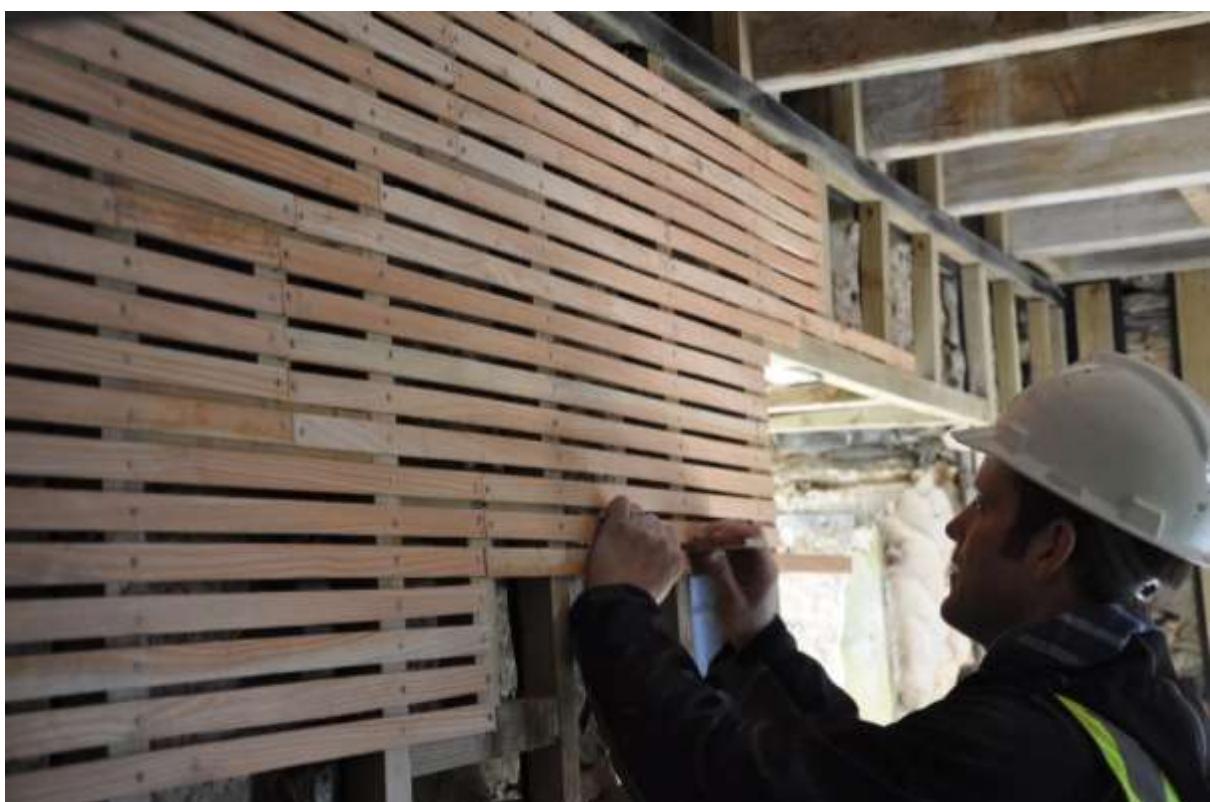
Figure 34: New sawn timber laths being fitted to timber framing

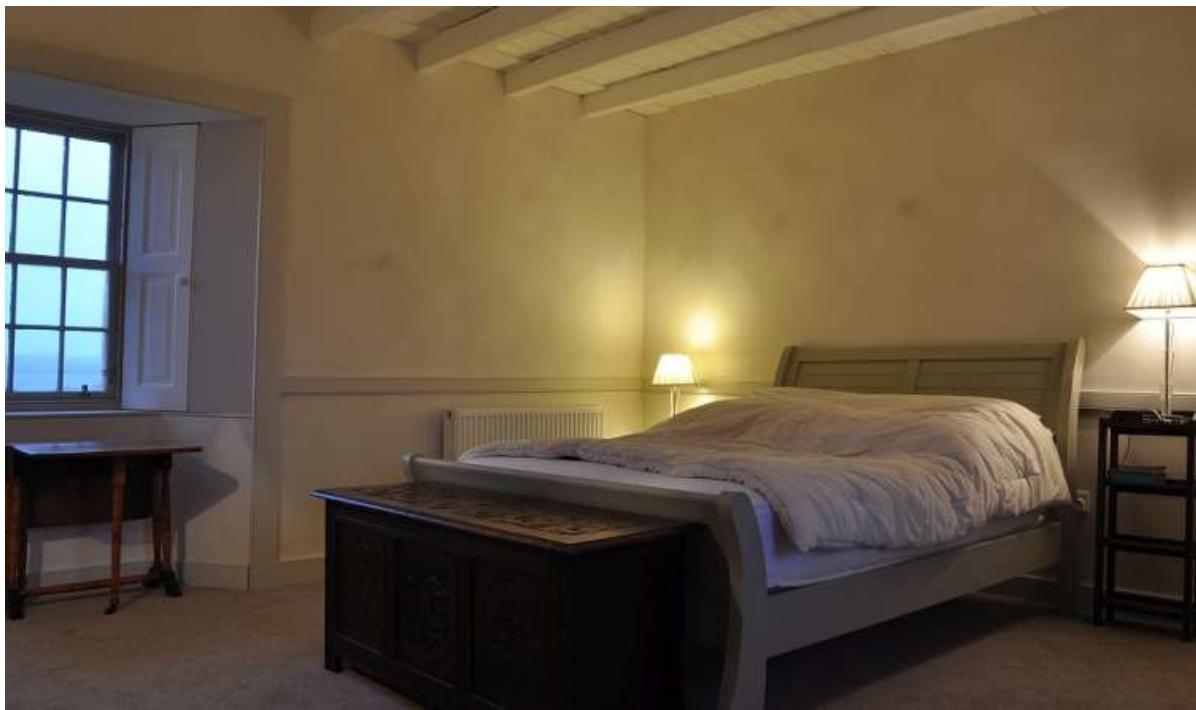
Figure 36: The first floor bedroom after the works lined with lath and plaster

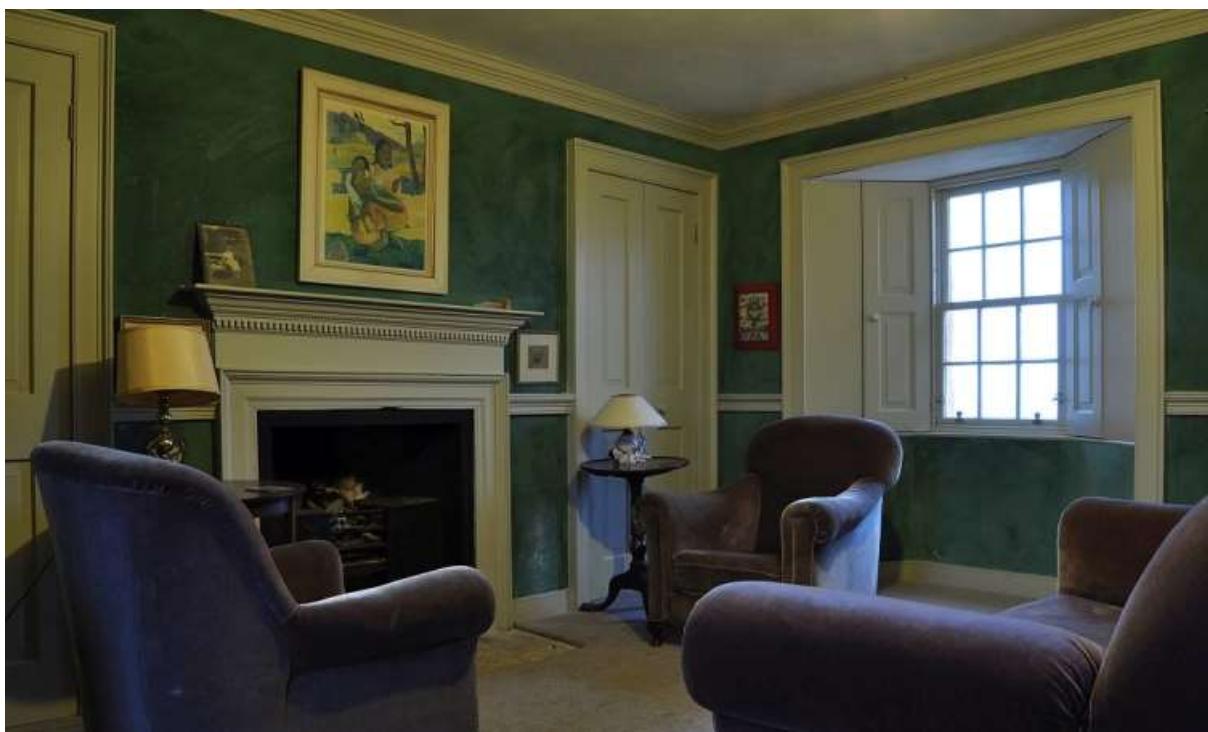
Figure 37: Drawing room after works with carpet laid over the timber floor

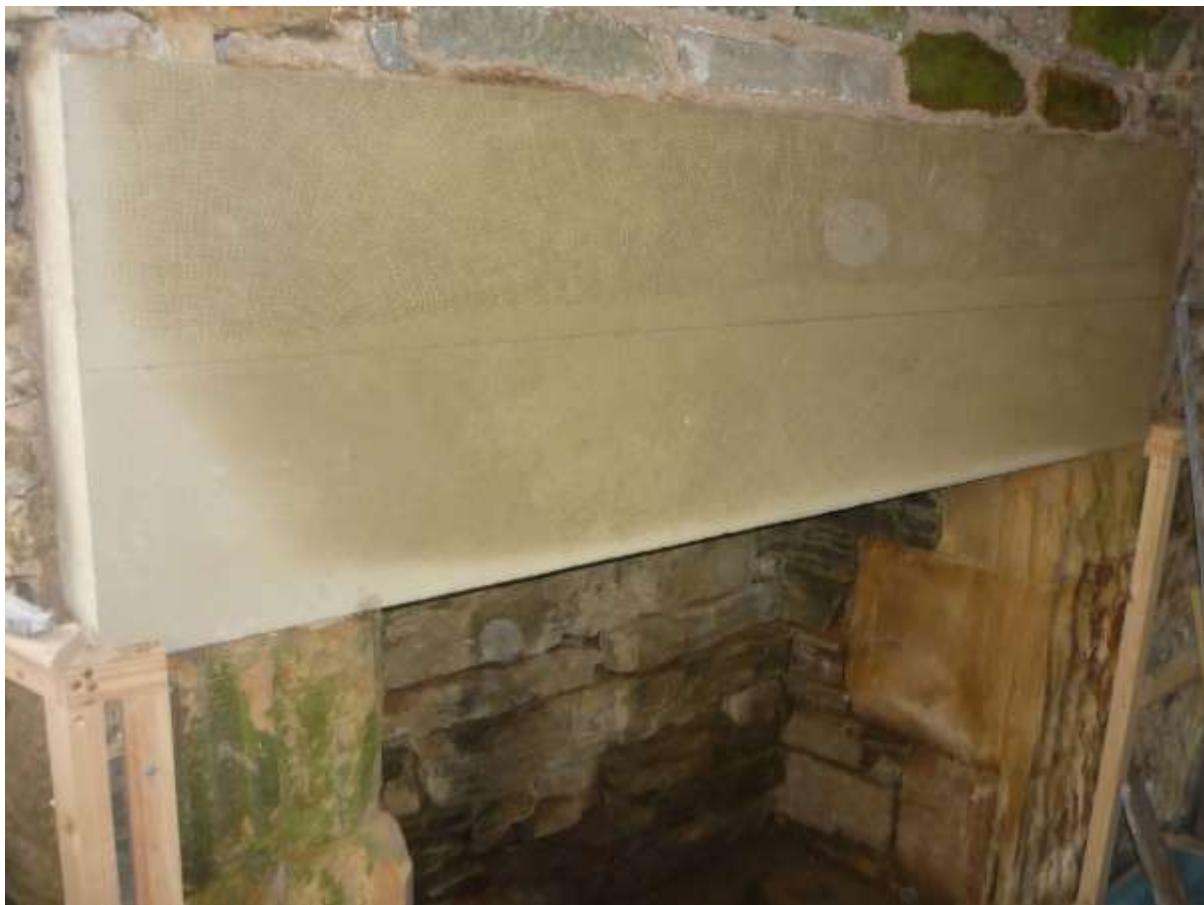
Figure 41: New stone lintel in situ above the ground floor fireplace in the west gable
